# THE CONTRIBUTION OF AIR CUSHIONED VEHICLES IN OIL SPILL RESPONSE<sup>1</sup>

Mac W. McCarthy  
Global Environmental, Inc.  
2763 13th Avenue SW  
Seattle, Washington 98134

Capt. John McGrath  
Canadian Coast Guard/SAR  
APO Box 23838  
Richmond, British Columbia V7B 1X9, Canada

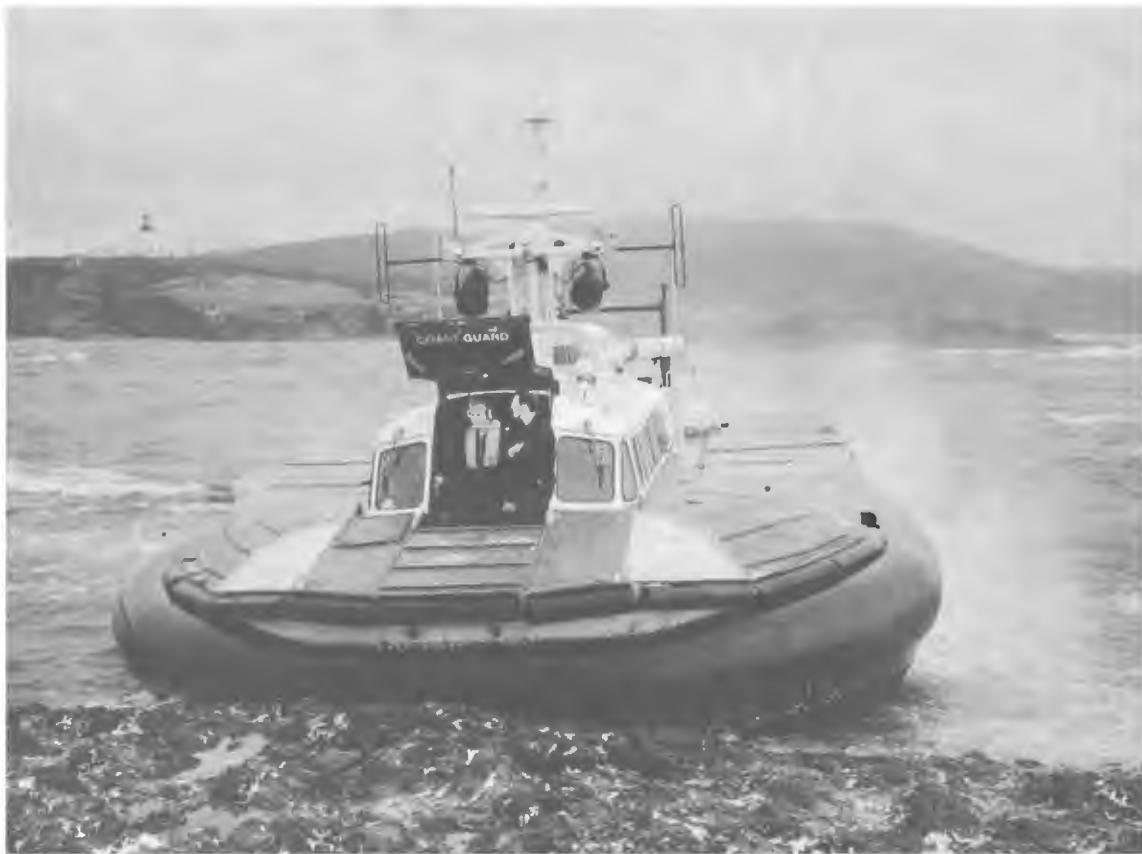
Figure 2. Hovercraft 086 holds position while scientists inspect the marine mammal rookeries off Tatoosh Island during the *Tenyo Maru* spill.

ton, the SRN-6 conducted surveillance on beaches, kelp beds, rookeries, and tidal pocket beaches. Landfalls, for inspection purposes, were made at Tatoosh Island and Titacoclos Falls Beach. The craft was dynamically held on station while observers departed to inspect the marine mammal rookery islands in the Tatoosh Island vicinity (Figure 2). Breaking surf usually makes these small islands inaccessible by boat. Pocket beaches, such as Hole-In-The-Wall Beach on the Pacific Ocean side, were visually inspected from the hovercraft. These tiny beaches, surrounded on three sides by sheer rock bluffs, are also rarely accessible by boat and represent a high-risk mission for a helicopter.

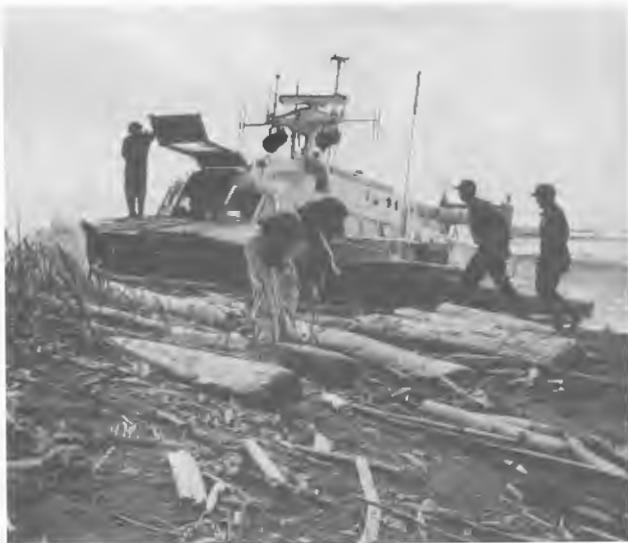
Figure 3. Cleanup crews working on First Beach during the *Tenyo Maru* spill are supported here by Hovercraft 086.

Two response crews, working on the Straits of Juan de Fuca, were supported from the SRN-6. One crew was harvesting oil contaminated kelp from small skiffs. The other crew was conducting traditional beach cleanup operations on First Beach of the Makah Tribal Lands. The SRN-6 successfully maneuvered bow on to the beam of the skiffs and dynamically held position while personnel and supplies were transferred. At this point, the craft actively demonstrated that it could safely support vessels ranging in size from the 272-foot CCG buoy tender *Martha L. Black*, working offshore at the wreck site, to a tiny 14-foot inflatable skiff working in shallow water, just off the beach. The beach cleanup crews were supported by making a landfall on First Beach to transport personnel and supplies (Figure 3).

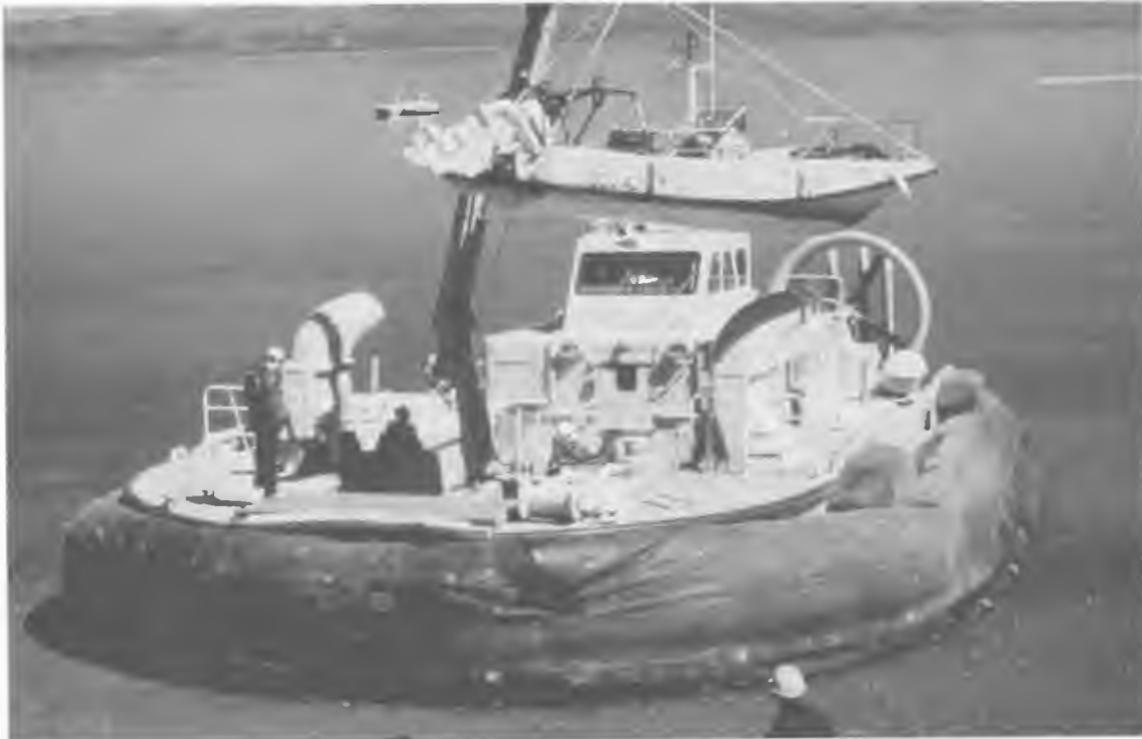
Figure 4. The hydraulic crane and well deck design of the *Waban Aki* enable the craft to support a broad range of response activities.

To assist the oil spill and salvage response, the Canadian Coast Guard deployed their hovercraft, *Waban Aki*. The *Waban Aki* is a modified British Hovercraft Corporation AP 1-88.250 hovercraft. It is 80 feet long with a 36 foot beam. Unlike the SRN-6 hovercraft, the *Waban Aki* is of well deck design with a bow ramp and a detachable hydraulic crane (Figure 4). The size and the well deck design enable the vehicle to carry a 22,000 pound payload at an average cruising speed of 35 knots.

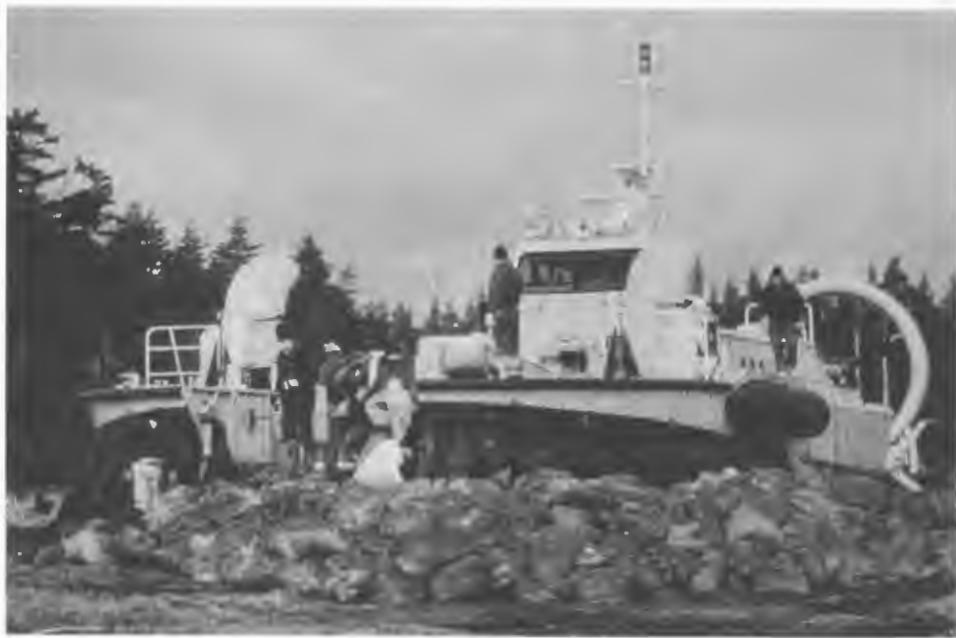
Figure 5. The *Waban Aki* loads contaminated soil at a remote location during the *Rio Orinoco* incident in the Gulf of St. Lawrence.

Prior to the arrival of the *Waban Aki*, cleanup crew deployment with boats, helicopters, and all-terrain vehicles had taken up to four hours. Replacing these conventional methods of logistical support with the hovercraft enabled the Canadian Coast Guard to transport, in a single trip, all 87 *Rio Orinoco* responders. Transit time, including stops at four different work sites, was under one hour. The hovercraft utilized its amphibious capabilities on days when sea conditions were extremely rough by shifting its operations to cruising over tidal flats. In addition to transporting beach personnel, the *Waban Aki* deployed containment boom, removed 764,000 pounds of contaminated soils from the beach, and ferried personnel and equipment to the grounded ship (Figure 5). These tasks were accomplished regardless of visibility conditions.
