INTERTIDAL ZONE OIL RECOVERY FROM THE BURIED DERELICT S.S. CATALA

M.W. (Mac) McCarthy
Mac McCarthy, Inc.
Edmonds, WA, USA

Devon Grennan,
Global Diving & Salvage, Inc.
Seattle, WA, USA

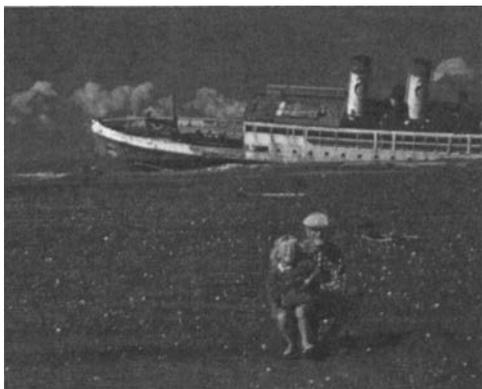
FIGURE-1: THE CATALA STILL INTACT AND PARTIALLY BURIED CIRCA POST-1965 (PHOTO COURTESY OF JIM WALKER)

Moored inside Gray's Harbor, the Catala became a casualty of a fierce winter storm on New Year's Day in 1965. The vessel broke free from her pier and partially capsized, filling with water. For the rest of her life she remained listing and stranded on the Damon Point spit (Figure-1). The Catala's final career was as an attractive nuisance where legions of teenagers conducted rites of passage on her canted decks and in her abandoned staterooms. It was all in good fun until injuries prompted officials in the early 1980's to cut her superstructure to the sandline and bury the rest. Nevertheless, nature has a way of overcoming man's best laid plans; winter storms washing over the Damon Point spit would periodically uncover portions of the ship. In the ensuing years, Damon Point

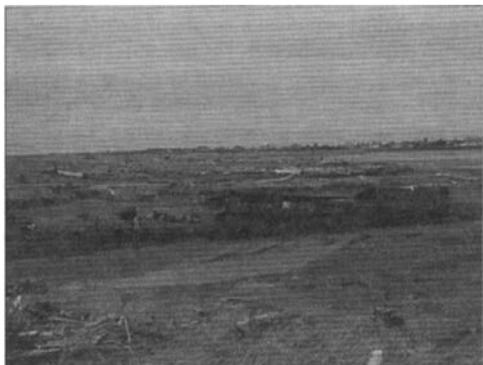
It was a beachcomber who in April 2006 discovered the threat of pollution from the Catala. Coming upon vestiges of the ship protruding from the sand (Figure-2), the gentleman thrust a stick into an unsecured portside hatch in the partially exposed deck. The stick was withdrawn dripping with black oil, an event that prompted the notification of the Washington Department of Ecology (Ecology). Quickly assuming the role of the lead agency, Ecology assembled an investigative team that included a naval architect, an environmental site assessor, an asbestos abatement company and a marine salvage contractor. During a two day site visit the team mapped the ship's resting position, confirmed the presence of asbestos, drilled 12 perimeter soil borings and secured the open hatch with a padlocked blind flange. It was evident that during the prior effort to bury the ship some or all of the fuel oil had never been removed.

FIGURE-2: THE VISIBLE PORTION OF THE CATALA IN APRIL 2006 (PHOTO COURTESY OF THE WASHINGTON DEPARTMENT OF ECOLOGY)

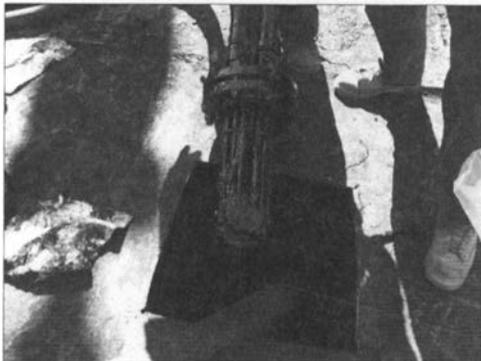
FIGURE-5: USING A HEAT EXCHANGER TO INCREASE PRODUCT TEMPERATURE AT THE PUMP SUCTION

subdivided into 1) methods that more or less uniformly increased product temperature throughout each entire tank, and 2) the application of localized heat through a heat exchanger to raise product temperature at the pump suction (Figure-5). Of the two, the localized method was selected although sufficient resources to heat an entire tank volume were mobilized to the site. Steam was the initial favored heat source until a consulting thermodynamic engineer made a winning argument for using a hot water system. Hot water would enter the heat exchanger at 200°F and be able to heat the surrounding oil to 120°F imparting nearly the same heat transfer ability as steam but with a simpler and safer delivery.

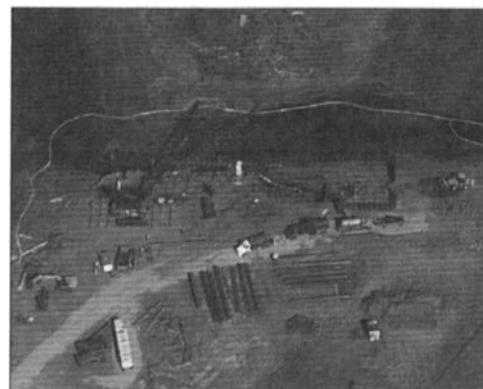
As the sheet pile wall progressed counterclockwise from the bow, excavation occurred to expose the dry upland portions of the ship (Figure-6). It soon became evident that not only had the Catala become buried by sand, but that the sand had also migrated into her interior spaces packing every void, a worst-case scenario volume calculated at 5,000 cubic yards. The tank tops had to be exposed to access the oil within. Deck space above the Forward Deep Oil Tank was easily cleared by an excavator. The space above the No. 1 Fuel Oil Tank, though within the excavator's reach, presented a greater challenge. A section of the port side shell had in previous years been cut away to the tank top while the starboard side shell and some decking remained angled at the final resting list. The excavator would have to approach the edge of the excavation cautiously scooping sand while maintaining a far enough setback to keep its ground pressure from collapsing the excavation. Sand removal from these exterior areas was periodically supplemented by the use of a small 1.25 cubic yard clamshell bucket. Though slow and requiring re-rigging of the crane head block, the little clamshell proved its value as the appropriate tool for vertically-accessible-only locations.

FIGURE-6: AERIAL VIEW OF THE CATALA REMEDIATION PROJECT (PHOTO COURTESY OF THE WASHINGTON DEPARTMENT OF ECOLOGY)

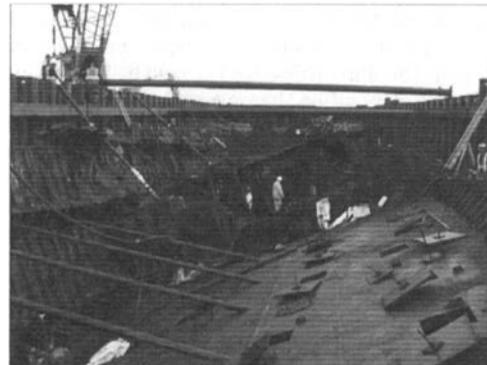
In reality the hull of the Catala was primary containment while the sheet pile cell and outer boom were respectively secondary and tertiary measures. Sand accreted on the decks and packed into the interior spaces performed two functions: 1) acting as a counter force against the inward bending moment of the surrounding ground and 2) serving as a sponge to wick tidal water throughout the hull. As that sand was removed, the risk increased that ground pressure might collapse the starboard side shell until the cell was completed. Additionally, upward hydraulic pressure from groundwater continued to force water through the porous hull, contaminating it with oil that clung to the ship's interior from historic releases. Consultations with the Glostien Associates naval architect convinced the project team that to guard against collapse of the starboard side shell, the hull would require diagonal bracing every 10 feet between the side shell and deck (Figure-7). Controlling the capillary movement of water could only be achieved by building false bulkheads between the tank tops and making the ship watertight between each bulkhead.

FIGURE-7: WORK ABOARD THE REINFORCED CATALA INSIDE THE SHEET PILE CELL
